Decontamination of Semi-invasive Probes

Health
Facilities
Scotland

Dr. Sulisti Holmes
Head of Decontamination & Incident
Reporting Investigation Centre

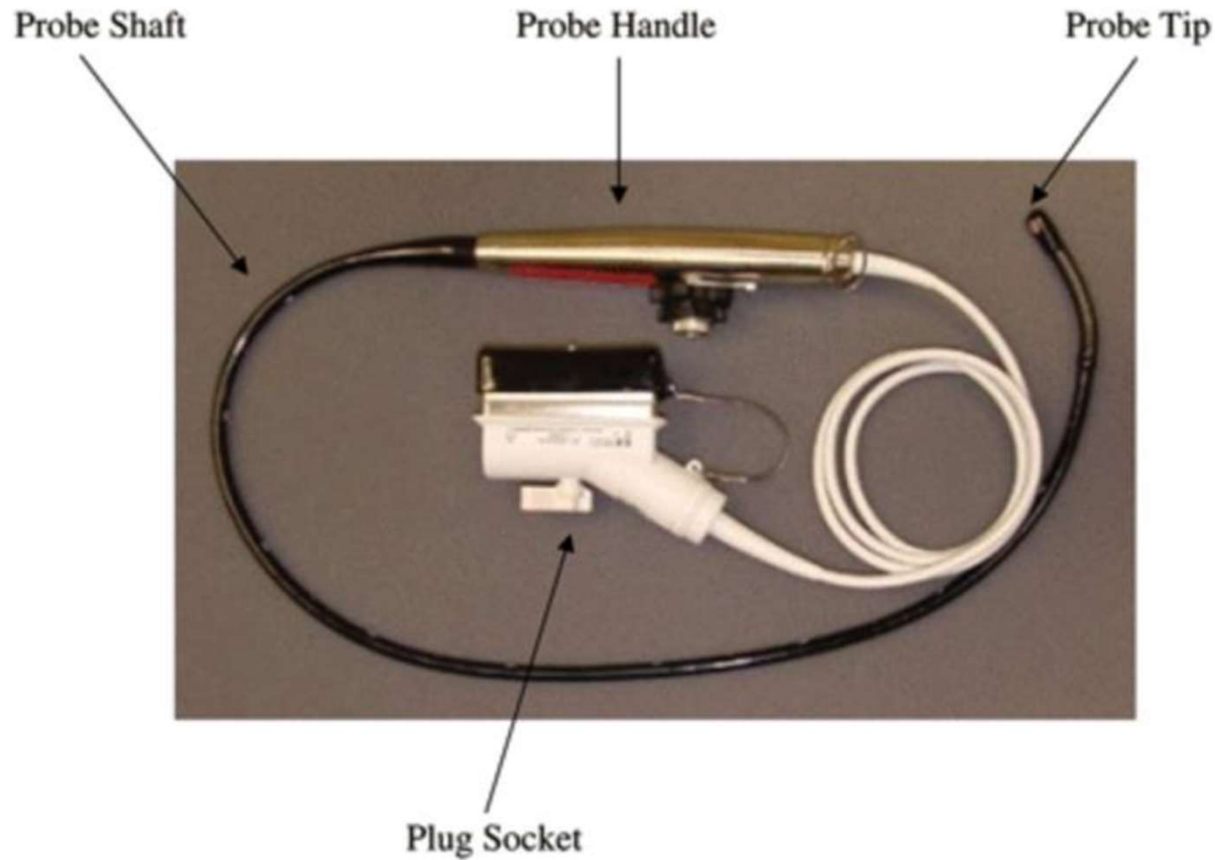
TOE (Transoesophageal
echocardiographic) probe

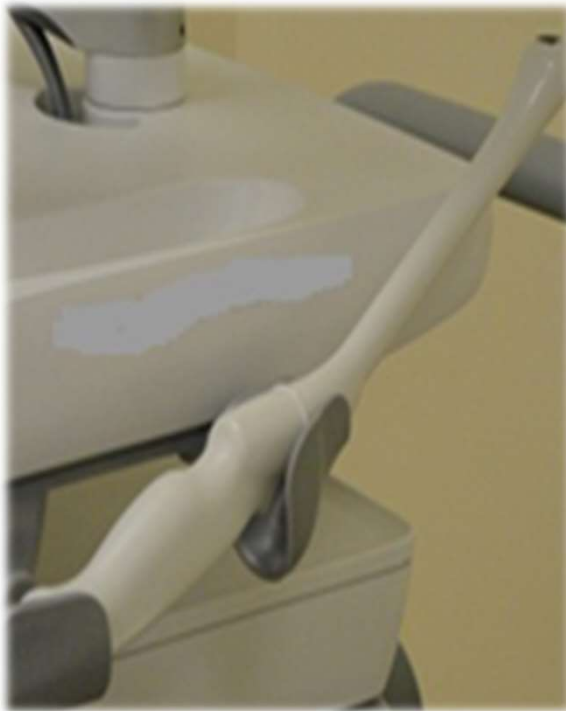
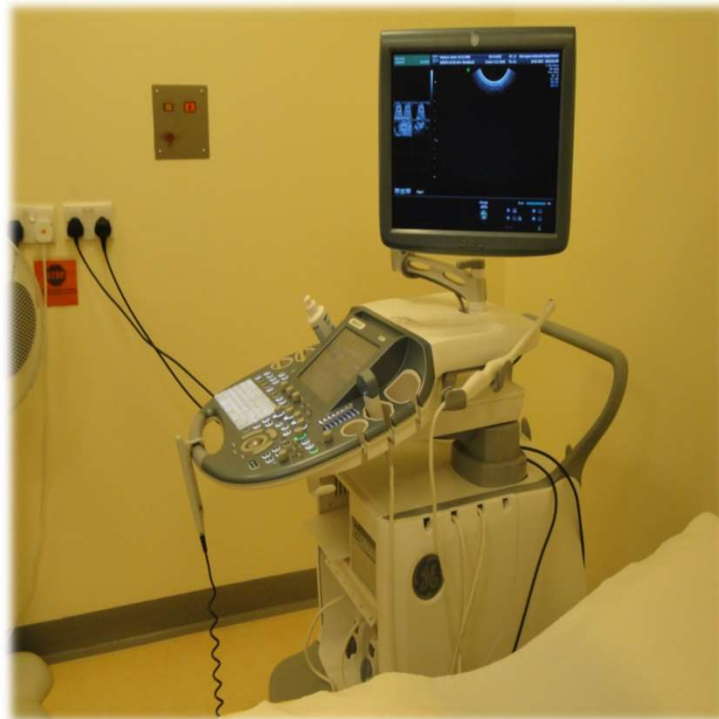
Transvaginal ultrasound probes (TVUP)
Transrectal ultrasound probes (TRUP)

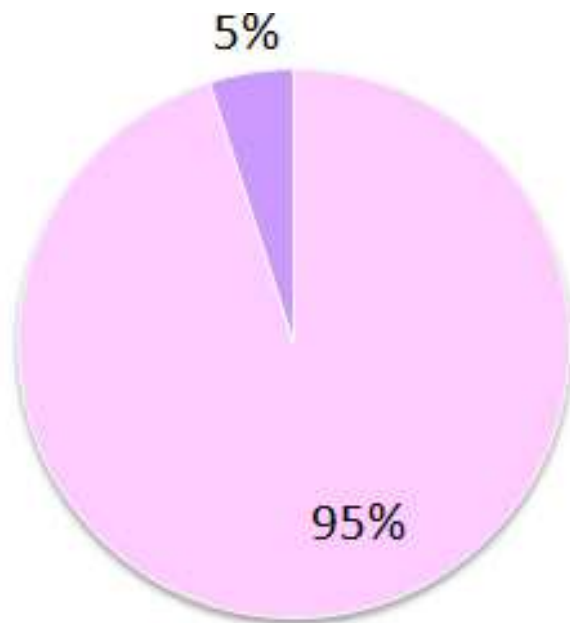
Awareness of the Alert

- Aware
- Not aware

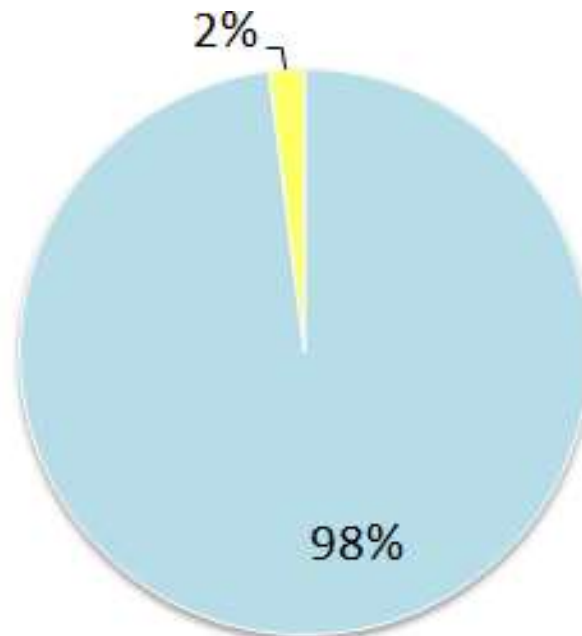
Decontamination staff

- Clinical staff
- Dedicated staff

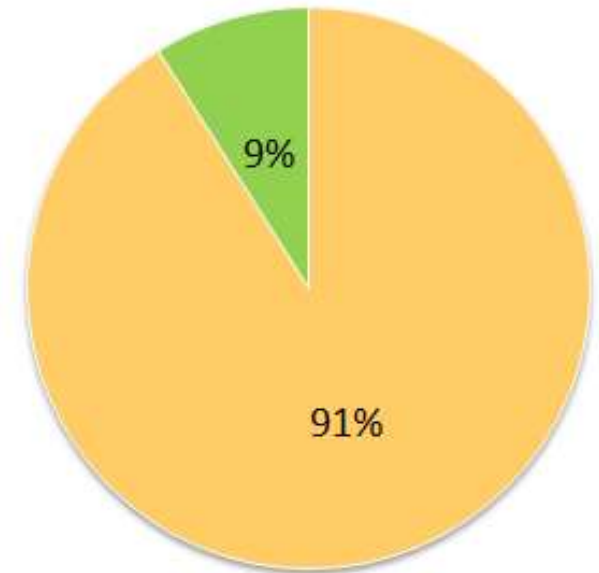
Location of decontamination process

- Clinical area
- Dedicated room

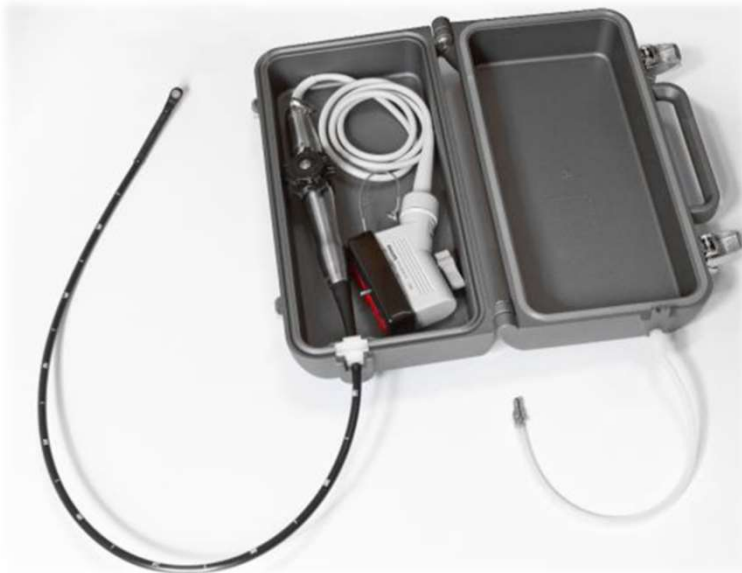
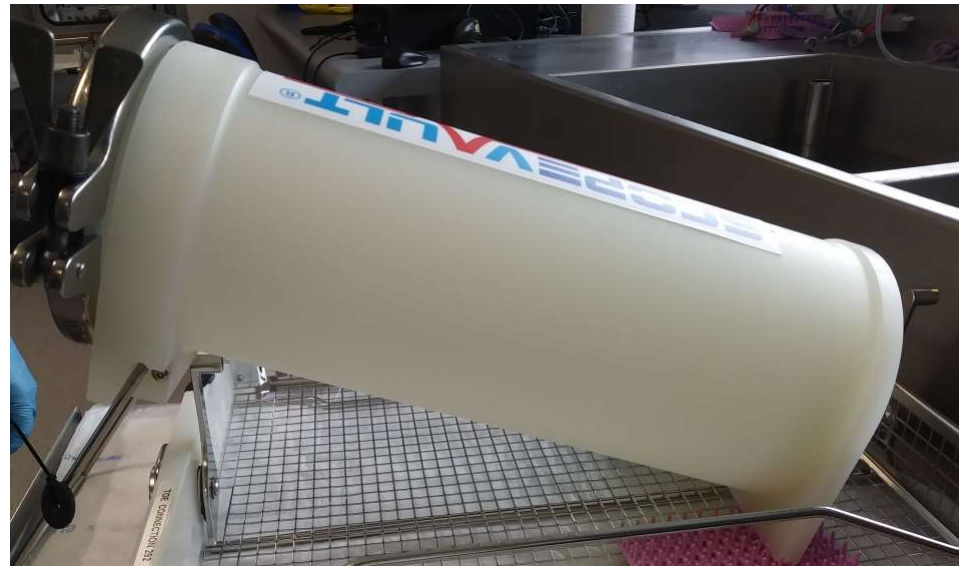
TOE Probes

- Decontamination **after each use** despite the use of the sheath
- **TOE** probes – **compatible Endoscope Washer Disinfector** in dedicated Endoscope Decontamination Units
- **TRUS and TVUS - 3 different disinfection systems** (preferably validated), locally by trained staff. Cleaning is still manual, not ideal but an improvement

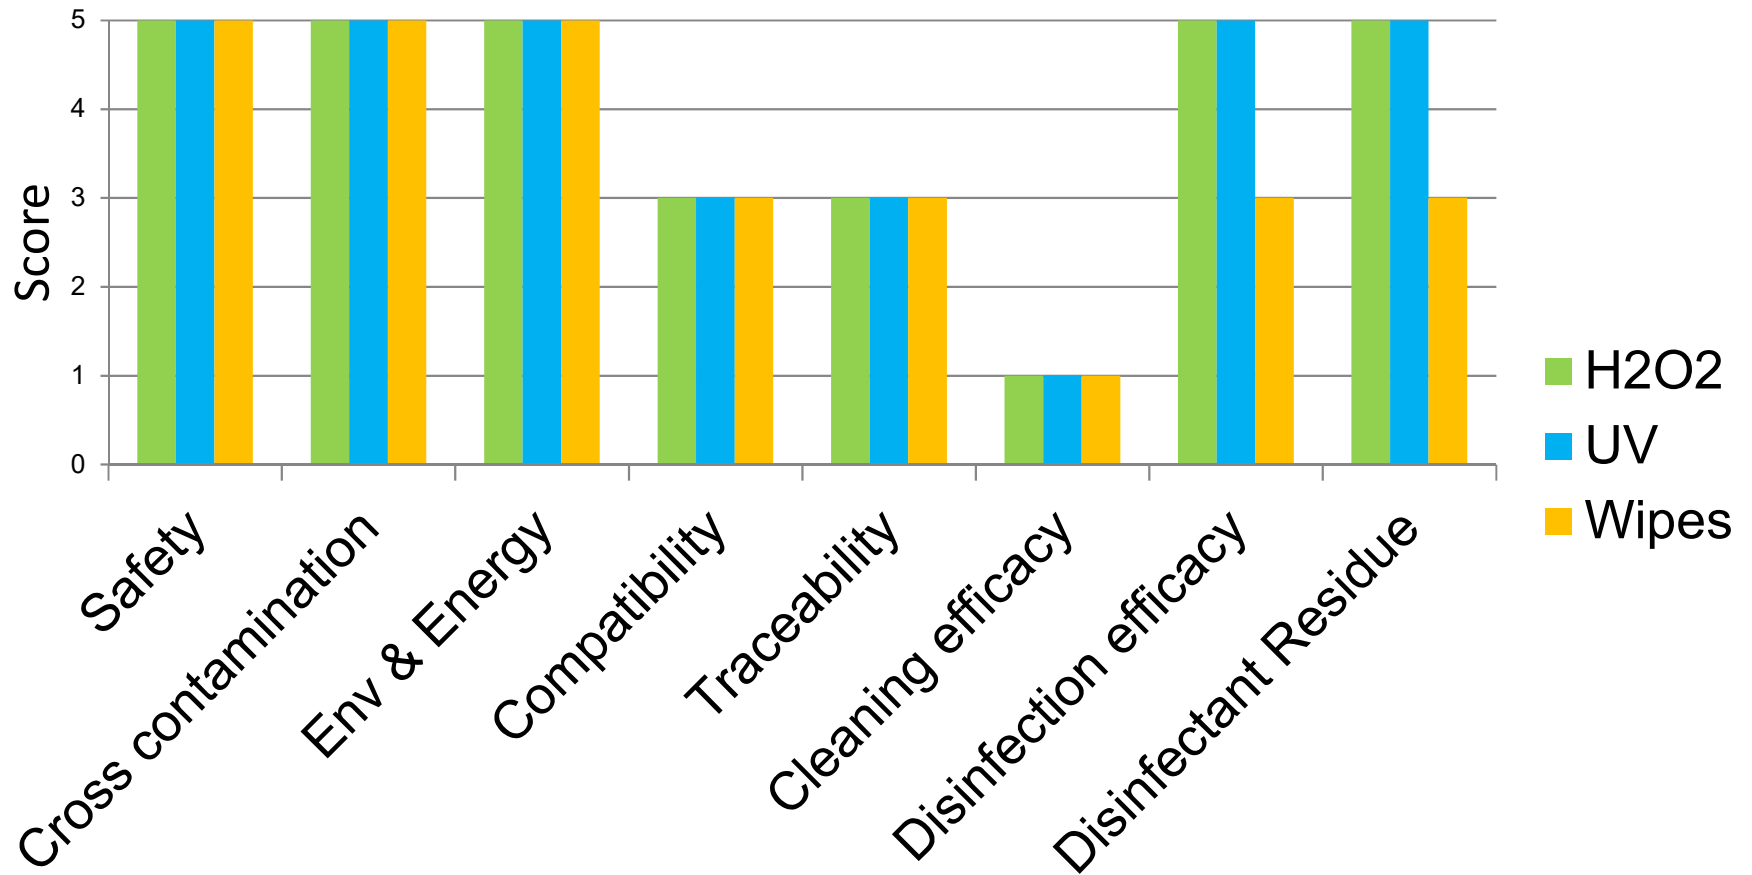
Assessment Results of Disinfection Systems

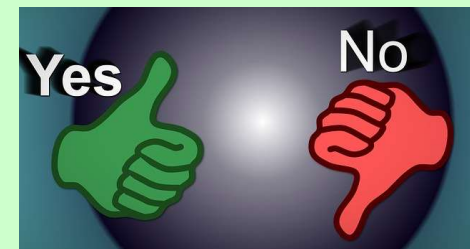
Hydrogen Peroxide System User Feedback

Training
Size
Safety
Ease of use
Reliability
Traceability manual

Adequacy of manual
Cycle time
Replacing the canister
Purging

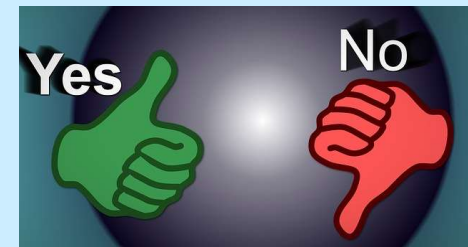
Ultraviolet System User Feedback

Rapid cycle time
Easy to use

Bulky
Poor Power plug

Reliability and
confidence
Training
Label supply
